Rice Lake Management Plan November, 2020 Iron County, Wisconsin

Rice Lake Association, Inc.

Aquatic Invasive Species Committee

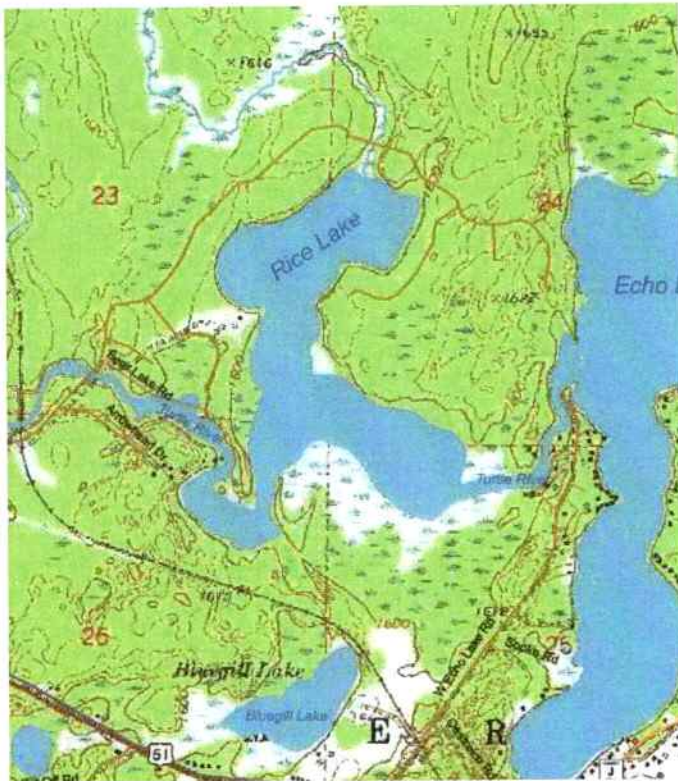
Figure 2: Topographical map showing Rice Lake, Iron County.

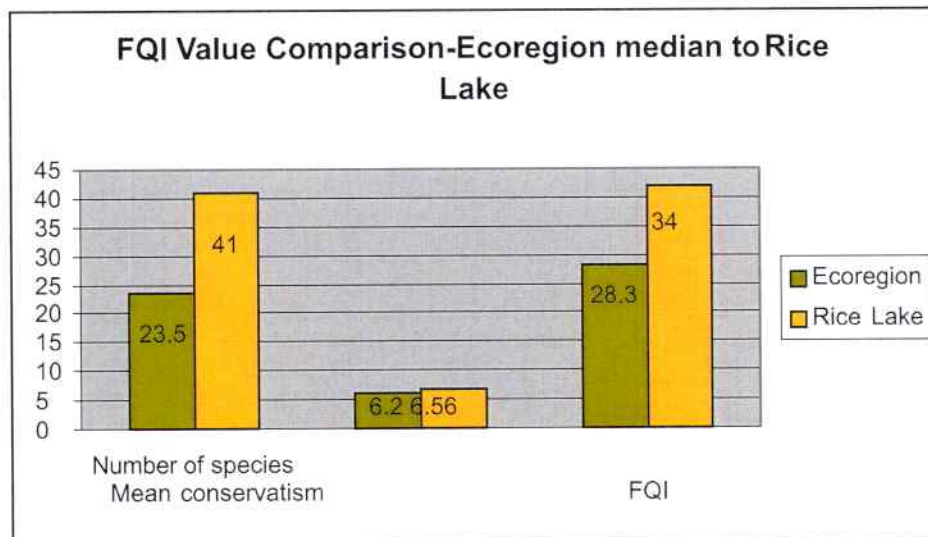
Figure 12: Comparison of FQI median value for the ecoregion (Northern Lakes and Forests-Flowages) to the Rice Lake FQI values.

The FQI for Rice Lake is very high. This shows that the plant community has several intolerant plant species. These are plants that do not respond well to habitat changes and/or water quality degradation in the lake. The mean conservatism for the Rice Lake FQI is 7 which is higher than normal.

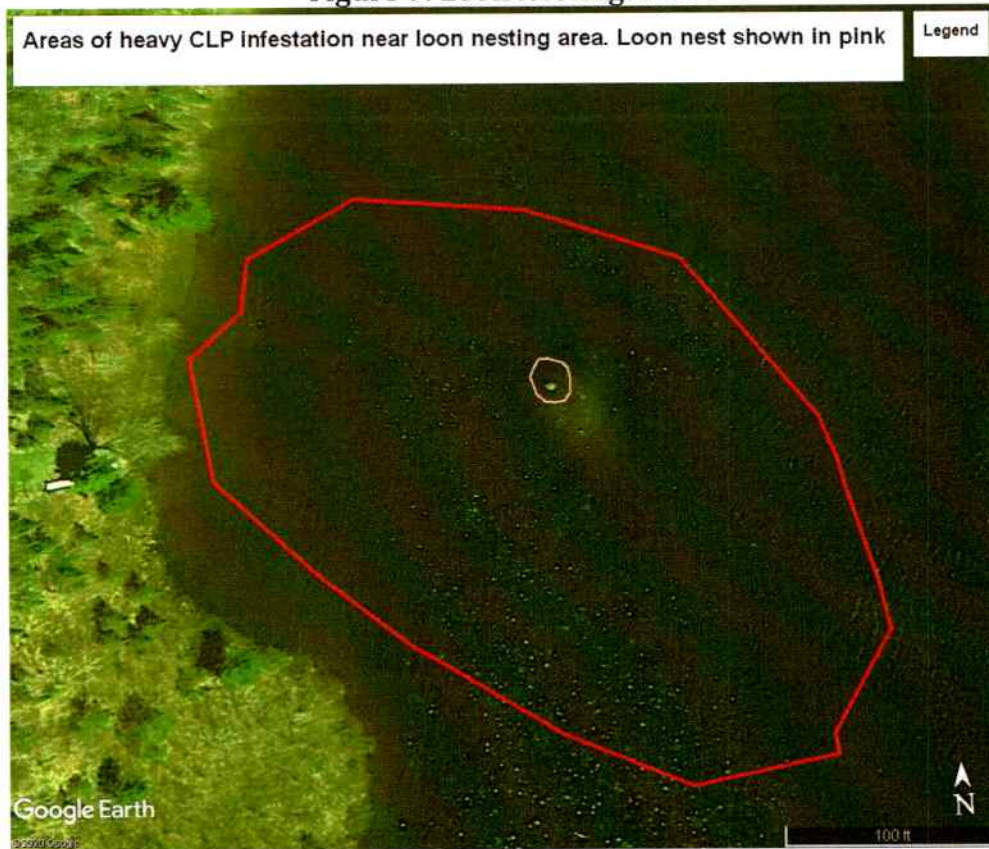
Figure 9: Loon Nesting area

A benthic barrier may be a potential option for Rice Lake around the aforementioned Loon nesting area. Since the main use of this management tool would be to retard and stop the early development of CLP and because that area of the lake cannot be easily hand harvested due to nesting of the loons it is considered a viable option. The area is small enough to be financially feasible even though a permit would be required. The barrier would be installed pre- nesting period and removed in two months, after hatching of the loons has occurred. This timeframe fits the recommendation of the manufacturer of the barrier. The area is delineated in a map attached which will show the size of the mat to be approximately 600 sq. ft.

The map below shows the location of the Loon nesting site on Rice Lake
